TEL001 – Summary of the April 2006 Repair Work
19-Sep-2006
Jamie Blowers, Technical Division

This is a brief summary of the work done to repair TEL001 (pressure vessel RSB-0536) in April 2006, during the extended shutdown. We attempted to capture the hours on job # 395 (project/task 30/30.9.1.1.5.1.1). According to TDCharge we logged 340.5 hours on this job. In addition 74.5 hours were logged on Machine Shop job V8559.

This note is an attempt to document the details of the TEL #1 (TEL001) leak investigation and subsequent repair.

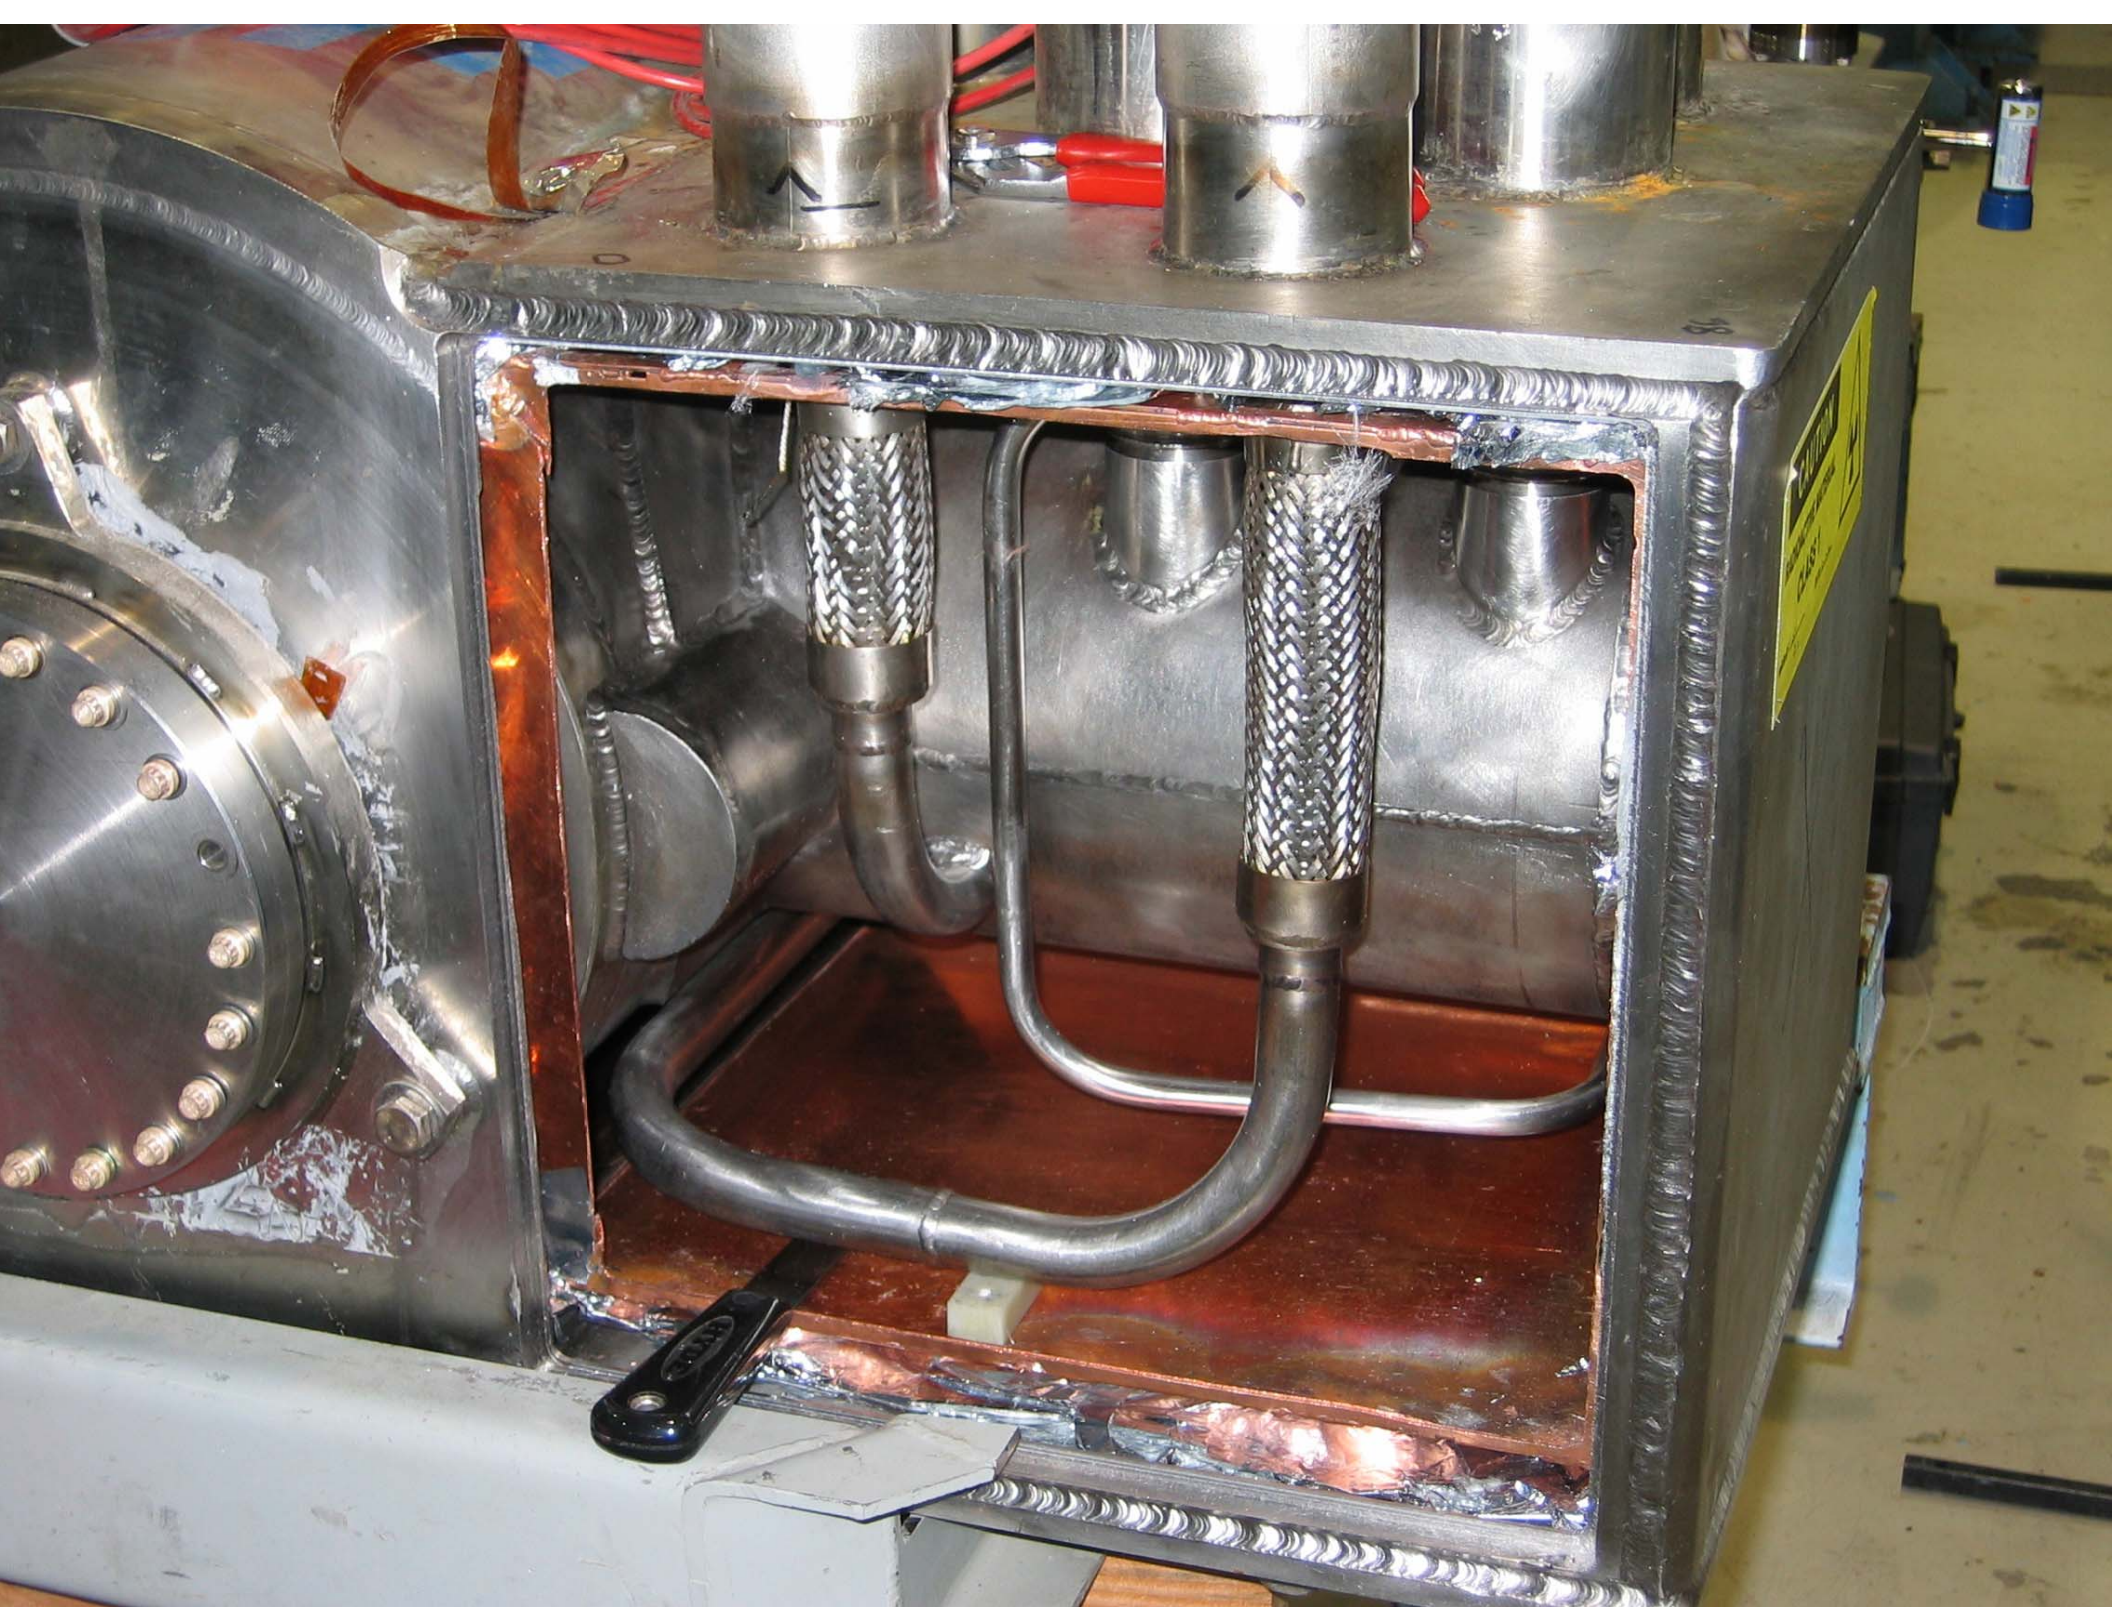
- Incoming inspection traveler (TR-308871) issued 18-Apr-2006
- Discrepancy Report number 4349
- TEL001 repair “blog”
- One picture of the repaired tubes. Notice that flex-hose was used, and we included a G10 block for support (see note from Cryo-safety review memo). In addition, numerous pictures are located in the network folder below. Each folder is dated and contains a brief statement of what the pictures are:
 \\tdserver1\project\proeng\MagnetPhotos\TEL\TEL001, or via <http://tdserver1.fnal.gov/project/proeng/MagnetPhotos/TEL/TEL001>
- Cryo-safety review memo (Bill Cooper)
- Pressure test plan (Bill Soyars)
- Pressure test permit and record
- Pressure vessel note amendment (proposal by Bill Soyars)
- Various drawings, mostly ones from IHEP. There is one from AD which shows the voltage tap configurations.
